TMS320F280013x Real-Time MCUs Silicon Errata

Silicon Revisions C, B, A, 0

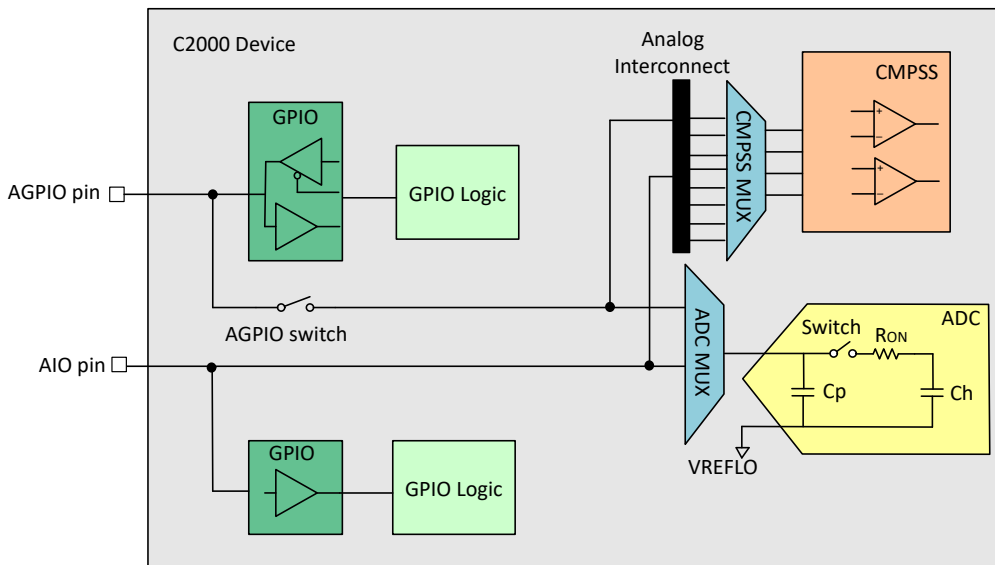
Figure 3-1. Analog Subsystem Diagram with AGPIO and AIO Analog Pin Types

The AGPIO analog pin path contains an extra series switch of 53Ω. This creates a low-capacitance isolated node shared by the ADC and CMPSS comparator, as shown in Figure 3-1. This node can be disturbed when the ADC samples the channel (depending on the prior voltage stored on the ADC sample-and-hold capacitor), and this disturbance can cause a false CMPSS event of up to 50ns. To accommodate this potential disturbance, the workarounds below can be implemented.

1. Use a different pin (that is AIO pin type) for analog channels that need both ADC and CMPSS together.
2. Use the CMPSS Digital Filter with a setting of 50ns or greater, which will filter the temporary disturbance.
3. Precondition the sample-and-hold capacitor of the ADC so that the disturbance will not cause a false trip. For example, perform a dummy read of a 3.3V connection from a different channel on the ADC immediately before the impacted channel is read, so the disturbance is in the positive direction, away from the false trip. The opposite dummy read of a 0V signal would be used if the false trip is inverted in polarity.
