41 PRESERVATION BRIEFS

The Seismic Retrofit of Historic Buildings: Keeping Preservation in the Forefront

David W. Look, AIA, Terry Wong, PE,
and Sylvia Rose Augustus

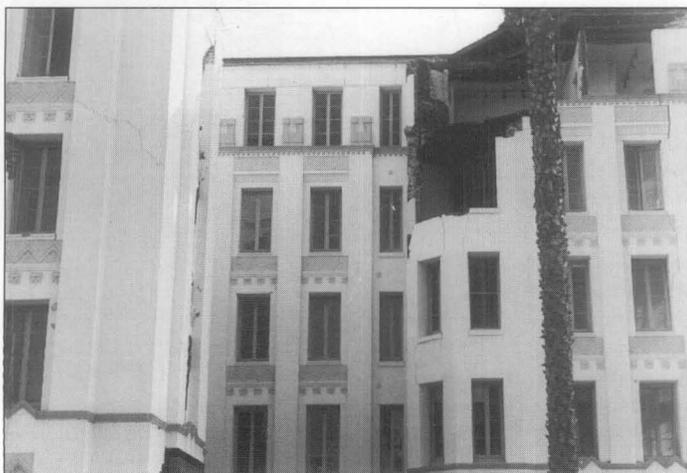
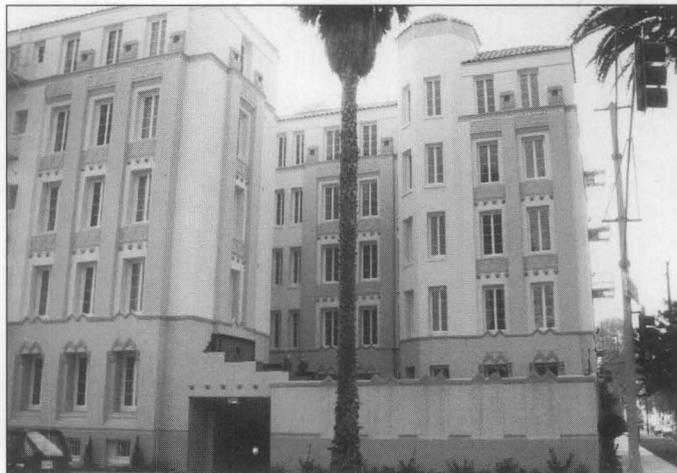
1. Earthquake damage to historic buildings can be repaired in a manner sensitive to their historic character as seen in this ca. 1928 five story apartment building. The owners used a combination of federal rehabilitation tax credits, community development block grants, and post earthquake grants to fund a portion of the rehabilitation and seismic upgrade costs. Photos: Historic Resources Group, Los Angeles.

Although historic and other older buildings can be retrofitted to survive earthquakes, many retrofit practices damage or destroy the very features that make such buildings significant. Life-safety issues are foremost and, fortunately, there are various approaches which can save historic buildings both from the devastation caused by earthquakes and from the damage inflicted by well-intentioned but insensitive retrofit procedures. Building owners, managers, consultants, and communities need to be actively involved in preparing documents and readying irreplaceable historic resources from these damages (see illus.1).

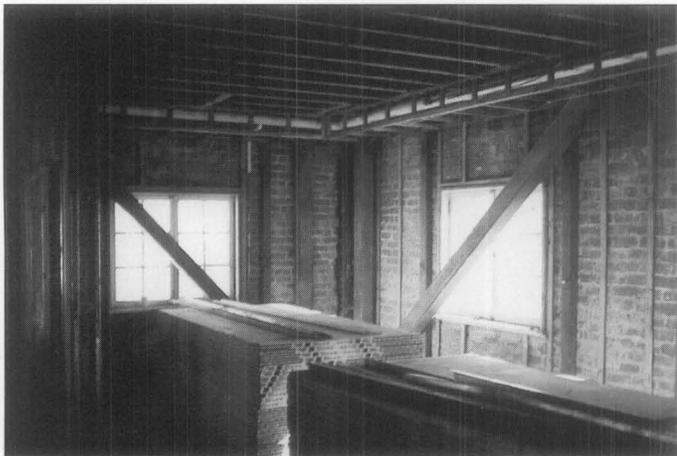
2. Standard approaches to seismic retrofit, as seen with the diagonally braced frame crossing in front of the historic windows, are visually intrusive. Solutions, such as using hidden moment frames around the perimeter of the window, will meet the goals of historic preservation and seismic retrofit. Photo: Steade Craigo.

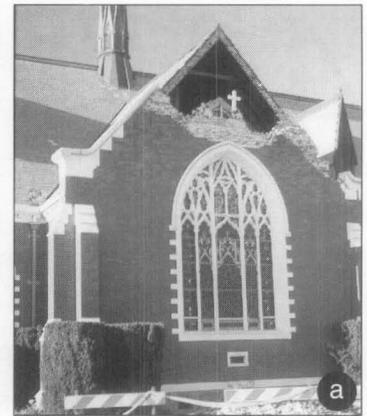
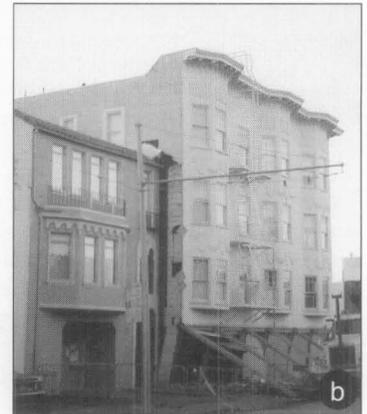
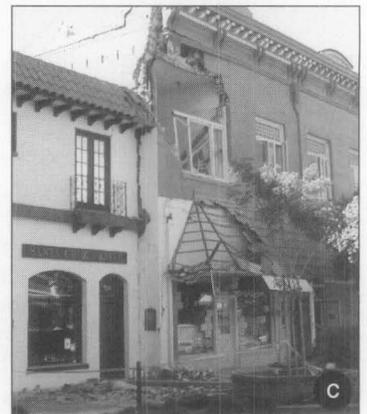
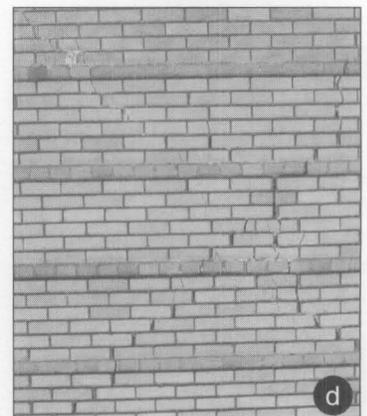
3. Forces from moderate to serious earthquakes caused a) the untied gable to fail, b) the first floor to collapse c) cracks from the pounding effect of adjacent buildings, and d) and diagonal cracks in exterior masonry between windows to form. Photos: David Look.

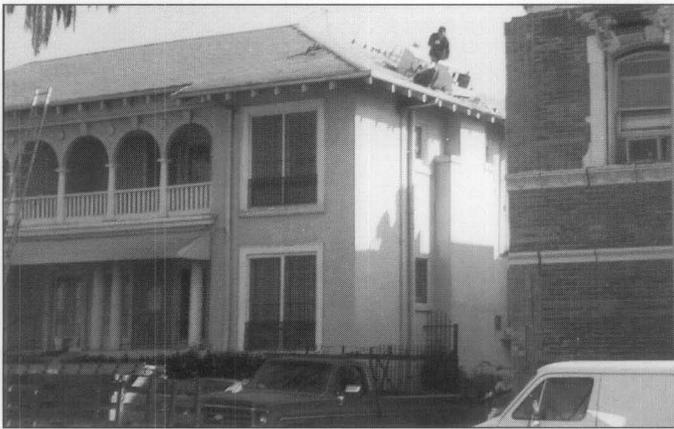
4. The compact size and good condition of the masonry building on the left withstood the earthquake except for the loss of the unsupported chimney at the roof line. The brick building on the right appears to have sustained more damage. Photo: Steade Craig.

The first three factors—the depth, duration, and proximity to the fault—are beyond human control. Recent earthquakes have shown the fourth factor, geological soil conditions, to be as important as any of the other factors because loose, soft soils tend to amplify ground motion, thereby increasing damage. Further, there is the tendency of soft, unstable soils to “liquefy” as the ground vibrates, causing the building foundations to sink unevenly. This fourth factor, geological and soil conditions, is difficult to address in a retrofit situation, although it can be planned for in new construction. The last two factors—the building’s construction type and its existing physical condition—are the two factors over which building owners and managers have control and can ultimately affect how the historic property performs in an earthquake (see illus. 4).

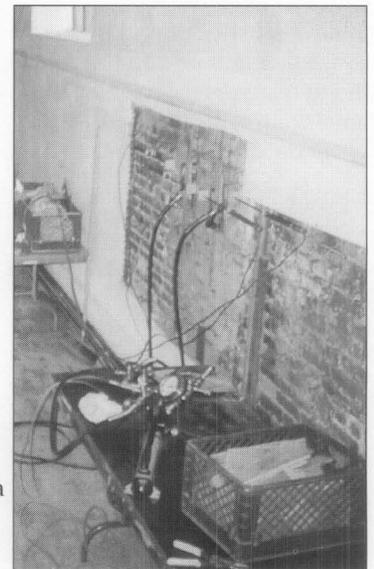
5. A careful program of in-place testing is essential to evaluate the existing seismic capacity of a building. This masonry push-test uses hydraulic jacks to estimate the shear capacity of the wall. Test locations should be in areas that do not destroy significant features and repairs should be carried out carefully. Photo: Architectural Resources Group, San Francisco.

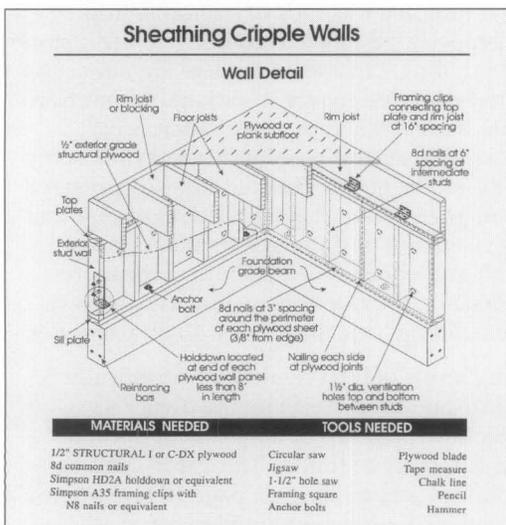
6. Often simple approaches, such as nailing plywood stiffeners between crawlspace studs and onto floor joist above and bolting sill plates to foundations can make a dramatic difference in protecting a building from seismic damage. Illustration: Reproduced with permission from Home Earthquake Preparedness Guide. EQE Incorporated, San Francisco, CA.

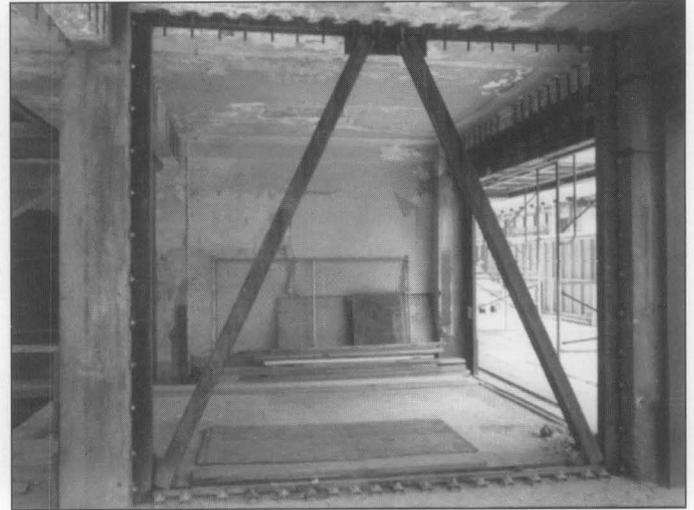
7. More extensive seismic issues can be addressed through structural reinforcement, the most common methods using anchor ties and braces. Shown here is an interior diagonal frame, to be covered, which will dampen and transfer seismic loads in a designed path from foundation to roof. Photo: David Look.

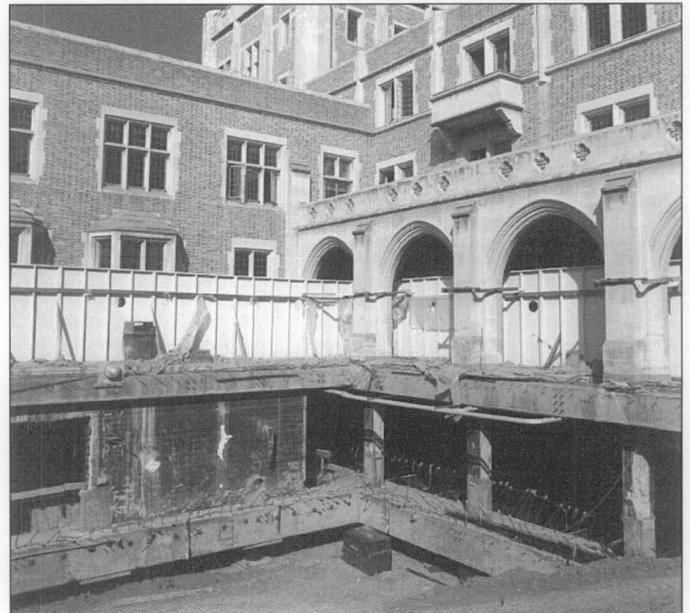
8. Full seismic restructuring to ensure that buildings survive a major earthquake with a minimum of damage may involve extensive reinforcement. Upon completion, the changes to this ca. 1932 Gothic Revival building to add base isolation at the foundation were not visually apparent. Photo: © Jonathan Farrer, courtesy University of California at Los Angeles (UCLA), Capital Programs.

3) *Enhanced Damage Control*. Historic buildings are substantially rehabilitated to meet, to the extent possible, the prescribed building code provision (See illus. 8). Some minor repairable damage would be expected after a major earthquake.

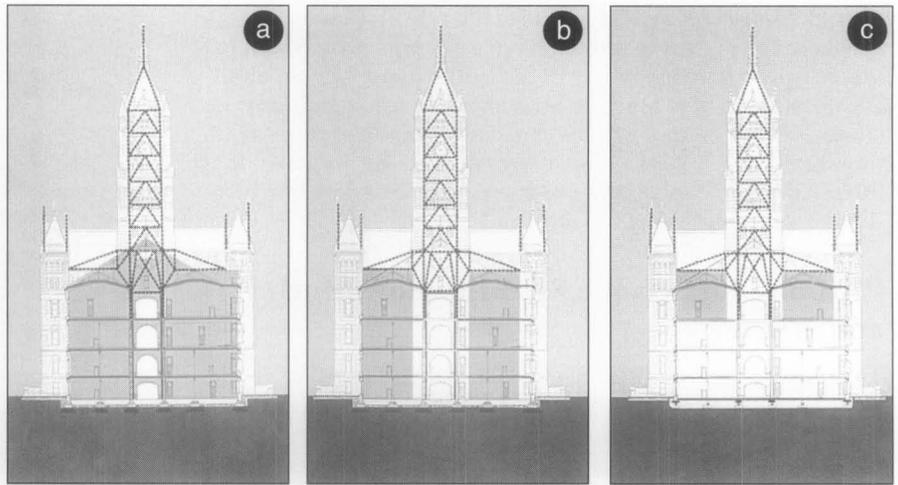
9. These studies for a public building compared, in the shaded areas, the amount of historic material that would be affected by (a) the Uniform Building Code requirements, (b) engineering alternatives that protected significant historic materials, and (c) the use of base isolation systems. The cost for implementing the 3 proposals was similar, and while proposal (c) was selected there were many positive aspects to both (b) and (c). Photos: George Siekkinen, with permission from Ehrenkrantz, Eckstut, & Kuhn Architects.

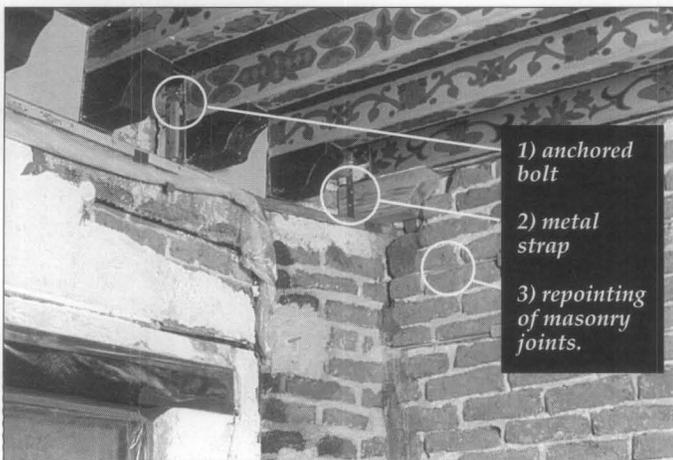
11. Limited intervention should correct obvious structural deficiencies, such as tying vulnerable elements together and repointing masonry. Seen here is 1) anchored bolt, 2) metal joist strap, and 3) repointing and reinforcing masonry joints. Upon replastering and painting these reinforcements will not be visible. Photo: Historic Preservation Partners for Earthquake Response.

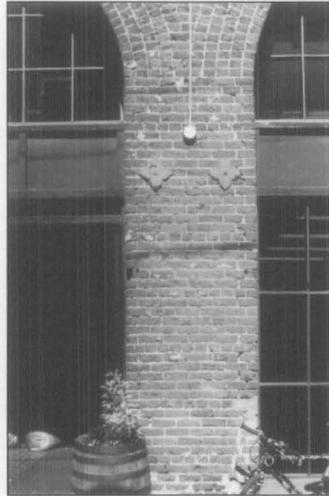
Recommended

- Use decorative washers in areas with high visibility.
- Align washers to create orderly appearance.
- Use stainless or galvanized steel and paint when appropriate, to prevent rust streaks.
- Attempt to conceal the bolts and washers below the exterior finish, when appropriate.

It is important to control rust by painting ferrous metal washers. New washers can be specified as stainless or galvanized steel. In circumstances where washers are visibly intrusive, the preferable solution would be to recess them below the face material. This is particularly applicable to stucco buildings.

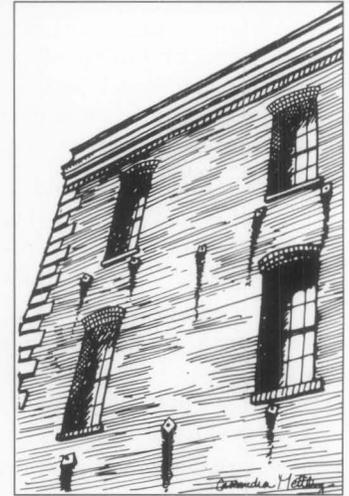
Not Recommended

- The anchor bolts on this building were placed in a haphazard fashion. More care should be taken to align the anchor bolt washers. Also, painting the washers can reduce the unsightly rust streaks that result from weathering.
- Do not place anchor bolts at locations with high relief ornamentation.

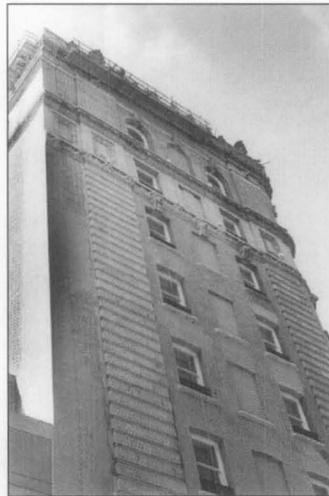
Recommended

- Infill of windows should be avoided in all cases. Where absolutely required, however, the appearance of a window opening should be retained to suggest the original visual rhythm of the facade.

The purpose of filling the openings is to increase the shear capacity and reduce the stresses on the unreinforced masonry wall. It is not adequate to just infill with the same unreinforced masonry, but generally a reinforced concrete, reinforced block or reinforced brick is specified. If infilling the openings appears to be the only realistic method, the design solution should be sensitive, and if possible, limited to secondary elevations. The opening should be set back and the facing material should be compatible with the surrounding material.

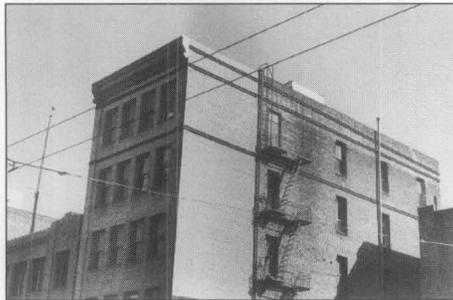
Recommended

- Exterior bracing or buttressing should incorporate the building's natural lines. The exterior steel bracing appears to be an original building element because it runs parallel to the cornice line.

Exterior buttresses, an integral part of Gothic architecture, are not traditionally part of our architecture. In retrofitting an existing building, it is usually better to use an in-wall or interior bracing system rather than a visible exterior system. When used as an exterior bracing system, care must be taken to avoid damage to existing decorative elements. Even if saved, exterior buttresses can obscure decorative elements.

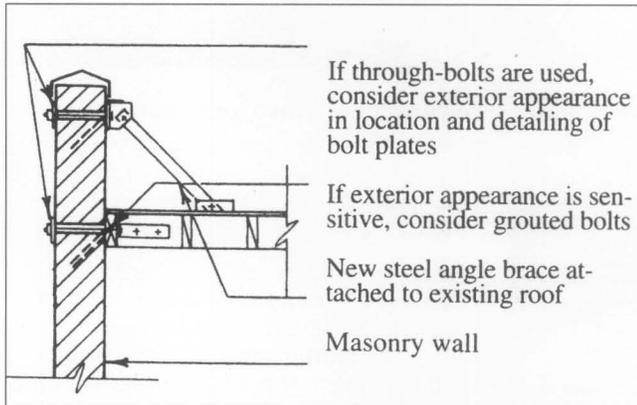
12. Bracing parapets, as illustrated here, and supporting chimneys using metal struts or ties, are simple methods to protect these heavy elements from falling. Drawing: Architectural Resources Group.

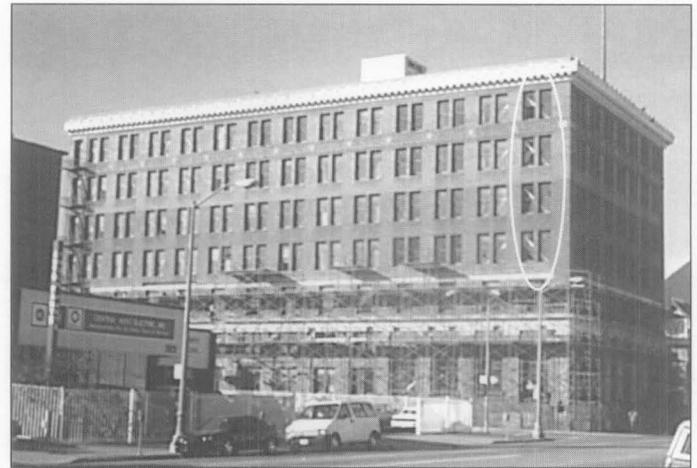
13. Installing diagonal frames, underway in this rehabilitation, are a traditional method of seismic reinforcement. To reduce the impact of the X, K, or diagonal braces, they should be on the inside of the perimeter wall, designed to cross behind solid walls as much as possible, and painted a receding color where visible. Photo: David Look.

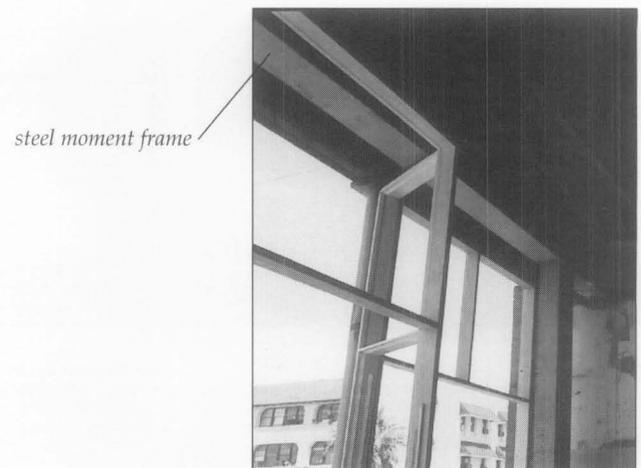
14. The use of a steel moment frame to support the large open storefront during a rehabilitation eliminated the need to place diagonal braces or other intrusive supports in a highly visible area of a historic building. Photo: David Look.

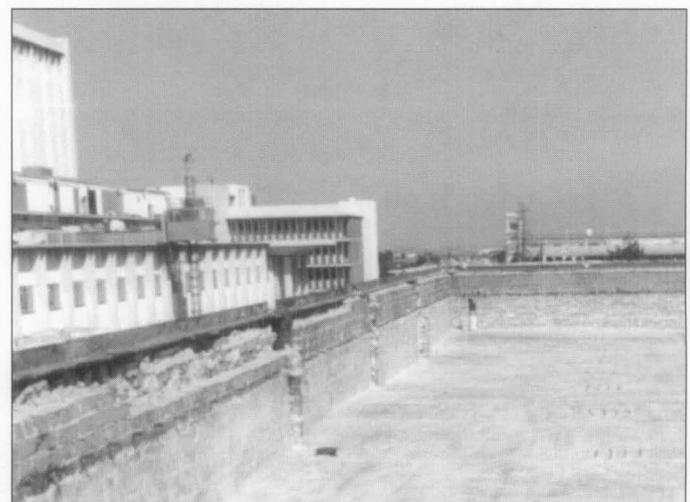
15. The use of fiber composite materials can enhance the shear capacity of existing structural components -beams, columns, and surface elements, such as walls and floors. In this roofing application, the existing roof diaphragm is being strengthened and there is additional benefit to the shear reinforcement of the parapet wall. Photo: The Crosby Group.

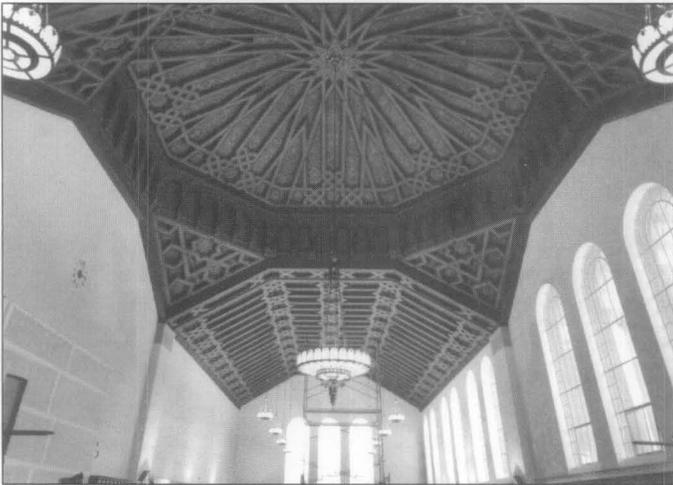
16. During the extensive rehabilitation of this historic building, new concrete, behind the new plaster finishes, strengthened the exterior brick walls and additional roof reinforcement was hidden behind the repaired/reconstructed coffered ceiling. Photo: © Jonathan Ferrar, courtesy UCLA Capital Programs.

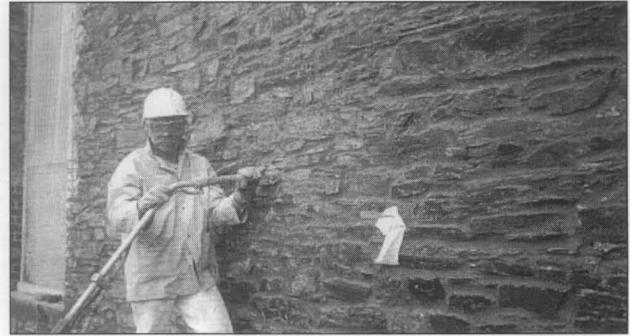
17. The internal grout injection of rubble walls can improve seismic capacity. Care must be taken in formulating the mortar grout and repairing the area where injection occurs. Photo: Architectural Resources Group, San Francisco.

- Consider the internal grouting of rubble masonry walls using an injected grout mixture that is compatible in composition with existing mortar. Ensure that exposed areas are repaired and that the mortar matches all visual qualities of the historic mortar joints in tooling, width, color and texture.

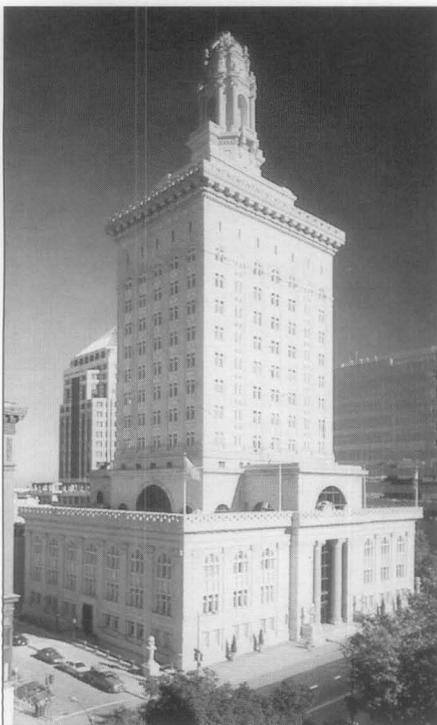
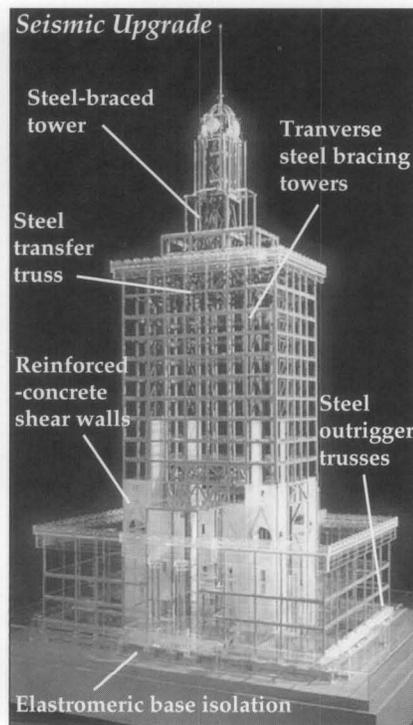
18. Oakland City Hall, California, completed in 1914, was restored to its original appearance and the computer model illustrates the comprehensive methods used to fully reinforce the building for the future. Photo: © Vittoria Visuals; Computer Model: © Douglas Symes, San Francisco. VBN, Architects and Carey & Co, Inc. Architecture.

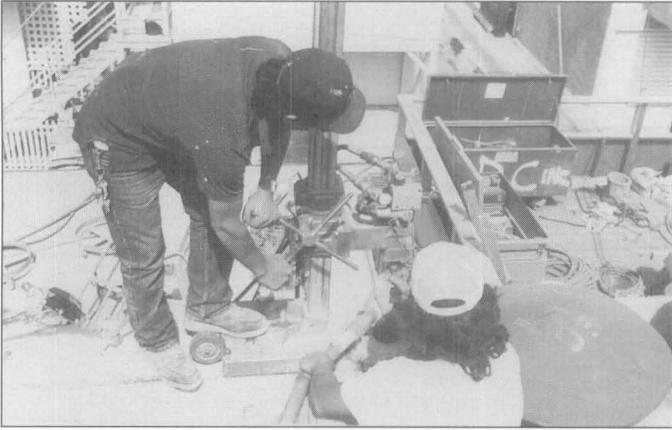
19. A system of core drilling, shown here, removes internal cored sections of unreinforced masonry from roof to foundations and fills them with grout and reinforcing rods. This may be an option for some unreinforced masonry buildings with significant interiors and exteriors, although it is a less reversible treatment than traditional diagonal frames or shear walls. Photo: David Look.

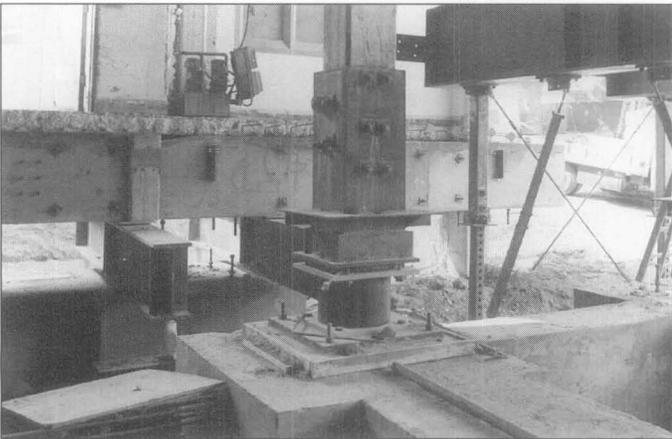
20. The new base isolator allows the structural support member at the foundation to move horizontally as it absorbs the earthquake forces. While expensive, base isolation may be justified by reducing the amount of damage to interior finishes and features with traditional methods of seismic retrofit. Photo: © Jonathan Farrer, courtesy UCLA, Capital Programs.

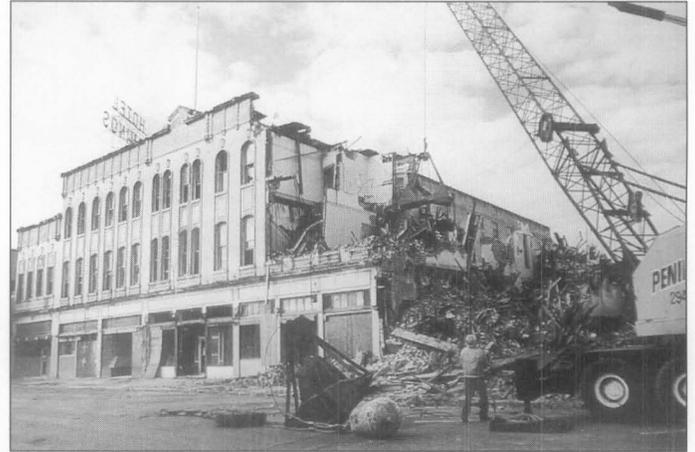
21. Without a plan in place before an earthquake, buildings that could be repaired are often torn down. The loss of significant numbers of buildings within historic districts can further erode the financial and cultural assets of an area. Photo: David Look.

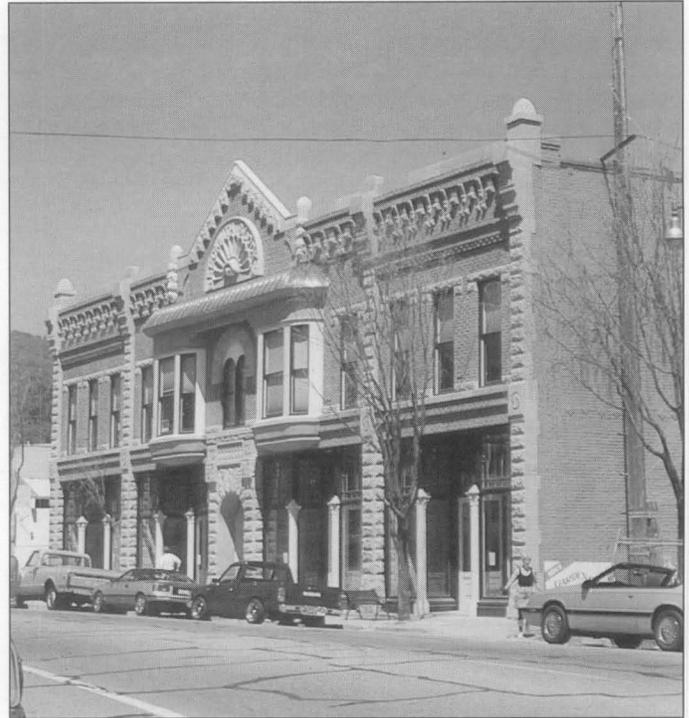
22. When undertaking a substantial rehabilitation to include seismic reinforcement, it is also an opportune time to restore lost or damaged features. The owner of this commercial building, using the Historic Rehabilitation Tax Credits, restored the original bay and parapet gable, and stone detailing that had been removed in an earlier insensitive remodeling. Photo: David Look.

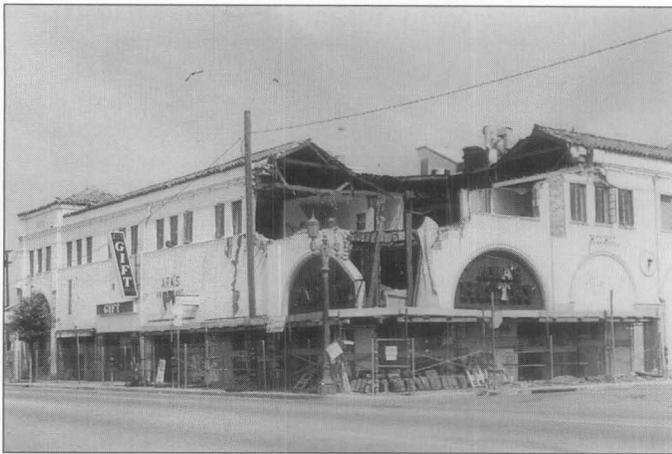
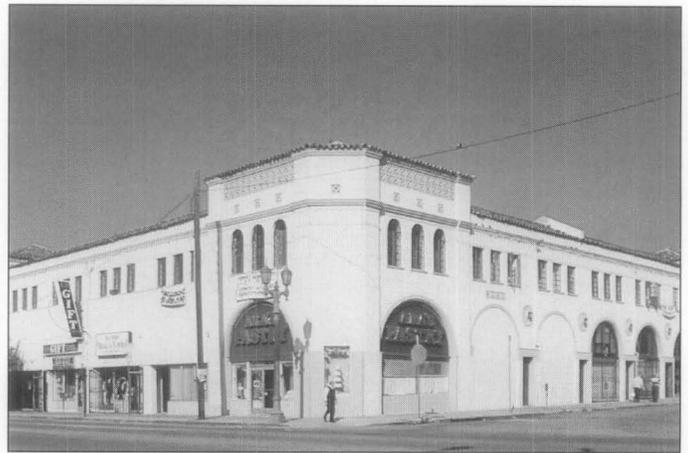
25. While it is best to seismically retrofit historic buildings before an earthquake strikes, if earthquake damage is to be repaired, it should be done in a manner respecting the historic character of the building. For this ca. 1925 Mediterranean Revival style building damaged in the Northridge Earthquake in California, financial and planning assistance from the Historic Preservation Partners for Earthquake Response made possible a sensitive rehabilitation. New structural steel and restoration of the historic stucco and decorative tile work and a repaired tile roof reinstated this earthquake damaged building as a major element of the historic district. Photo: Courtesy Historic Preservation Partners for Earthquake Response, M2A Architects.
